**AIChE Paper Number 125f  
Presentation ID# 351282**

**FLANGE CORROSION: PREVENTION AND MITIGATION THROUGH  
BETTER GASKETING**

*Kathryn Worden, Applications Engineer, Flexitallic, Deer Park, TX*

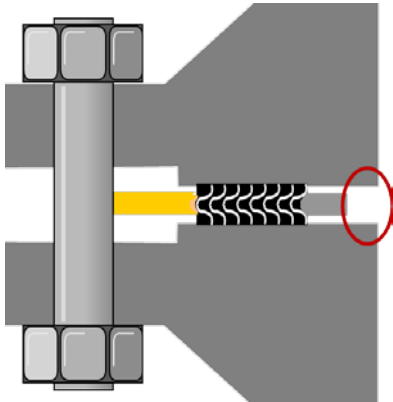
**Figure 1.** Standard spiral wound with inner ring – crevice at ID

Consider bolted flanged connections using different gaskets in Figures 1 through 3. In each situation there is a crevice or gap at the ID of the gasket to the bore of the pipe. Furthermore, even if a spiral wound has an inner ring, it will not necessarily be fully engaged when compressed, leaving crevices above and below the inner ring. It is possible for aggressive media to gather in crevices and initiate flange corrosion.

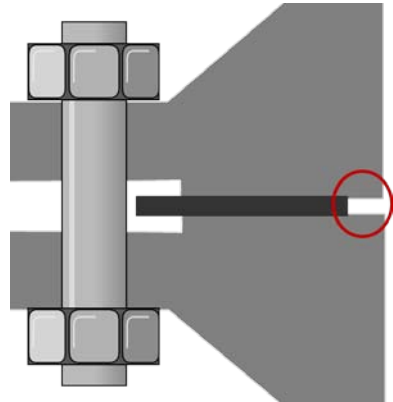
**Figure 2.** Standard cut sheet gasket – crevice at ID

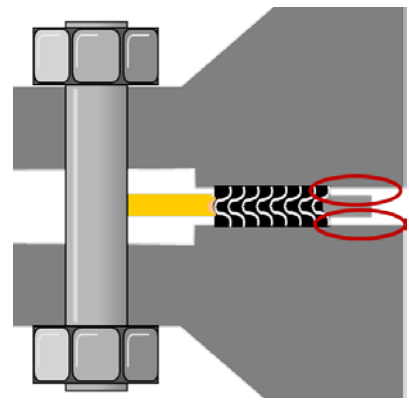
**Figure 3.** Crevices above and below spiral wound inner ring

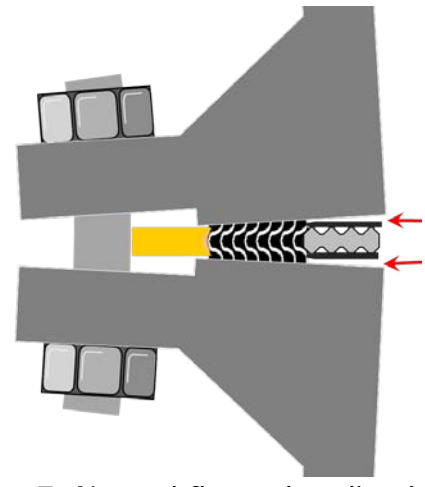
**Figure 5.** Natural flange bending leaving crevices above a kammprofile inner ring.

Recent flange corrosion history in hydrofluoric acid has also shown that thick, rigid inner rings – for example a kammprofile inner ring shown in Figure 4 – will also leave crevices. Insufficient compression, combined with natural flange bending and rotation, prevent full engagement of the kammprofile inner ring. Bolt load is around the OD of the flange which causes bending around the bolt circle and the flange to lift off the gasket ID. Refer to Figure 5.

Compare this to a gasket that utilizes a spiral wound as the main sealing element (minimum seating stress 10,000 psi) and a kammprofile inner ring taken to the bore (shown in Figures 4 & 5). Gaskets combining spirals and kammprofiles designed to the bore require tremendously high bolt stresses to seal the full gasket area. On some NPS and pressure class combinations, one would have to exceed flange or bolt yield stresses to compress the full gasket area. Furthermore, compressing the full gasket area on some sizes won't be possible as flange rotation will occur preventing a kamm inner ring from ever engaging. For these reasons, this style is not ideal for corrosion prevention.

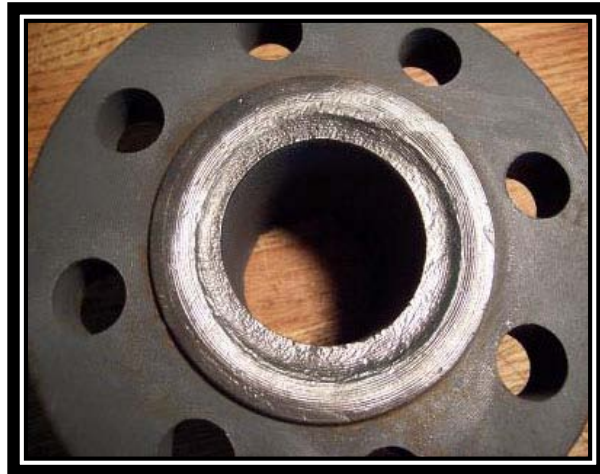
**Figure 6.** Crevice Corrosion at the ID of the flange

An example of the crevice corrosion described in both sections above is shown in Figure 6 for a typical raised faced flange.

The majority of HF acid alkylation systems are designed with carbon steel flanges. Although this metallurgy is acceptable, in certain areas of the alkylation process where there is higher risk and tendency for moisture to enter the system, flanges often corrode like that shown in Figure 6. Coupled with the requirement to use graphite based gaskets for compatibility and fire safety, corrosion can easily be initiated and accelerated. Operating with industrial clamps is a fact of life in these plants and every turnaround is lengthened by costly, detailed work to repair and replace corroded flanges.

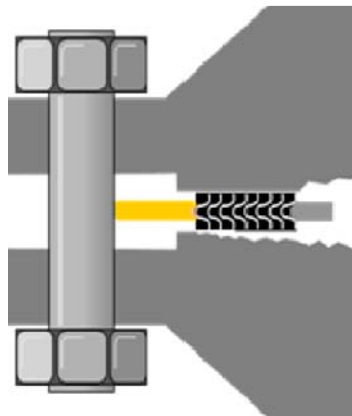
**Figure 7.** Corrosion eventually extends across the sealing face to the point of leak.

Most plants don't have the luxury of shutting down for frequent flange repair. If the flange corrosion progresses to a point at which leak occurs (see Figure 7), an industrial clamp must be applied to contain the leak and sustain operation. Industrial clamps have become a tolerable necessity for maintaining production but are a bandage for the real problem. The above risk, repair time, and funds spent are preventable with the right gasket.

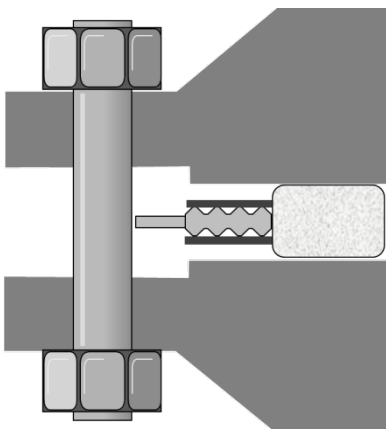
**Figure 8.** CPG, ¼" inner ring designed to eliminate crevices; Kammprofile is the primary seal

CPG combines a kammprofile sealing element with a ¼" thick inner ring made of highly compressible and conformable, fully restructured PTFE (henceforth referred to as fr-PTFE). This is the most important component of the CPG and is essential to eliminating crevices. This in turn prevents the onset of corrosion. The ¼" thick inner ring is designed to the pipe bore (specifically 1/16" outside to account for minor misalignment) to eliminate any crevices at the ID. Its thickness also eliminates crevices that might be left from a rigid inner ring. Refer to Figures 8 & 9 for cross-sectional representation in a bolted joint before and after compression.

The primary seal is a kammprofile, also known as grooved metal with covering layer, or GMCL and is illustrated in Figure 8 and 9 above. A solid metal core machined with concentric serrations and faced with a sealing material provides for high tightness and low emission sealing. Because of its solid metal core construction, it is capable of sealing Class 150 to 2500 flange applications. Metallurgy is selected to fit the service. Facing may be chosen from the common options of PTFE, graphite, and exfoliated vermiculite. Graphite is acceptable in the CPG because it is isolated from corrosive media by the fr-PTFE inner ring, and graphite remains the standard choice. Another fire safe and high temperature facing option is exfoliated vermiculite. Figure 10 illustrates a complete gasket.

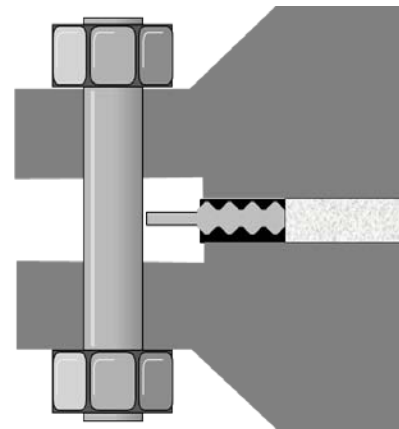
**Figure 9.** CPG inner ring fills all crevices upon compression

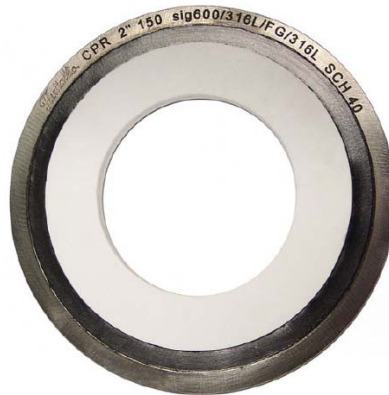
**Figure 10.** NPS 2" Class 150 Schedule 40 CPG

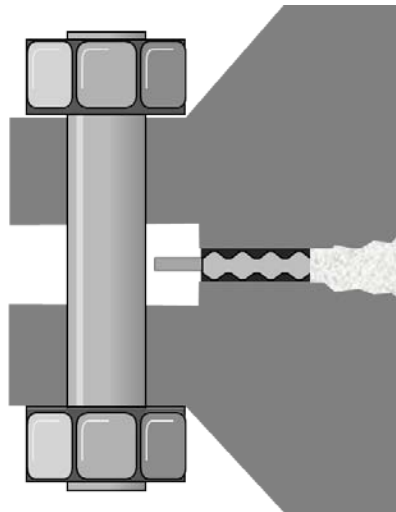
**Figure 13.** CPG sealing existing corrosion; Corrosion is inboard of the kamm ID.

The CPG has been found to seal existing flange corrosion in emergency situations. As long as the corrosion has not extended to the ID of the kammprofile core, the CPG may be considered for sealing against flange corrosion and resisting further flange deterioration. To allow for this possible use, the CPG core is dimensioned slightly more narrow than standard and also further outboard so sealing will begin immediately at the OD of the raised faced. See Figures 8 and 9 above. As depicted in Figure 13, the ¼" thick fr-PTFE inner ring conforms to the corroded flange in the same fashion described previously to eliminate crevices.

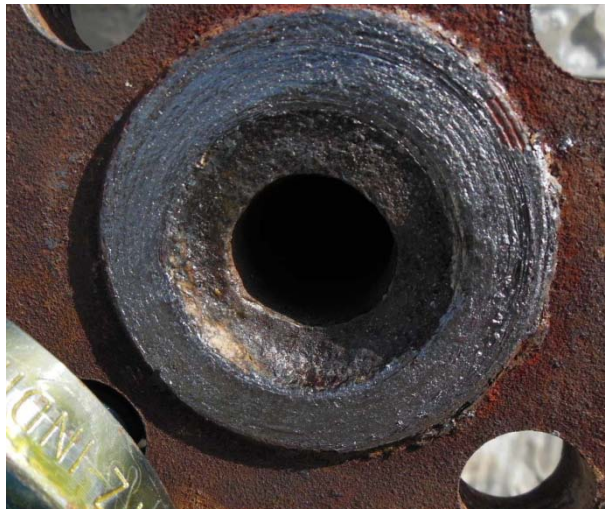
**Figure 14.** NPS 1" Class 150 SCH 160 Carbon steel flange corroded by HCl.

The phosgene tower at this specialty chemical manufacturer is a dry system. However when moisture accidentally enters the tower, phosgene reacts to produce hydrochloric acid which aggressively corrodes the carbon steel flanges. Every plant must balance the need to operate safely (which is paramount) while satisfying budget constraints and customer order requirements. After evaluating the NPS 1" Class 150 Schedule 160 corroded flange shown in Figure 14, measurements indicated the corrosion did not extend to the kammprofile ID of a CPG 1" 150. A CPG with an Alloy C-276 core was installed on this flange as well as a 2" 300 Schedule XXS. Although the manufacturer considers this a temporary fix until they can shutdown long term to replace each flange, these CPGs installed on May 2013 have allowed them to operate continuously leak free as of March 2014.
